BV100 firmware version 4.14 released

BV20 firmware version 4.16 released

DA3 SMART Update Tool - Euro €10

Bezel Error Codes

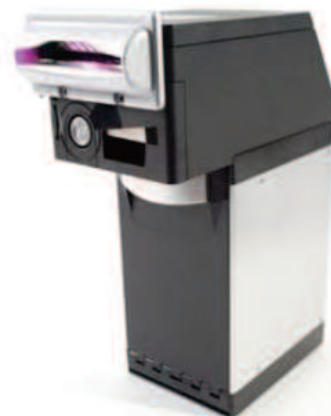
NV200

In the event of an error validator bezel LEDs will flash to indicate the specific error cause. A handy crib sheet has been created, understanding error flash codes for ITL devices, which can be found at the end of this bulletin. The one page document lists error codes for the NV200, NV11, SMART Payout, NV9 USB, NV10 USB and the BV Series as well as how to interpret flash codes for the DA3 handheld programmer. The example below details error codes for the NV200.

Flashes		Indicated Status / Error
Red	Blue	
0	0	None
1	1	Note Path Open
	2	Note Path Jam
	3	Unit Not Initialised
2	1	Cashbox Removed
	2	Cashbox Jam
3	1	Firmware Checksum Error
	2	Interface Checksum Error
	3	EEPROM Checksum Error
	4	Dataset Checksum Error
4	1	Power Supply too Low
	2	Power Supply too High
	3	Card Format
	4	Payout Reset
5	1	Firmware Mismatch

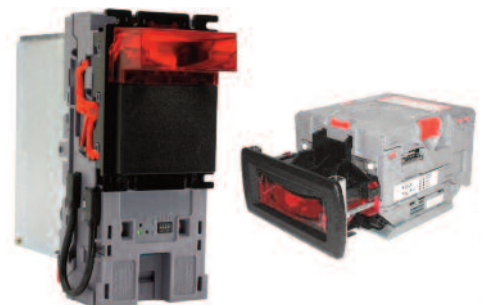
The original NV9 & NV10 have Dipswitches

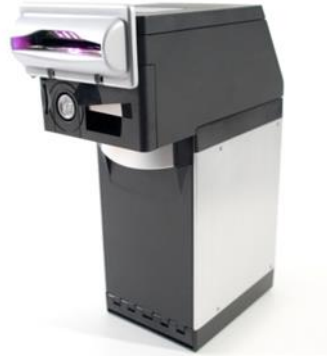
NV11 (Note Float)

Flashes	Indicated Status / Error
Off	Normal Operation
Constant flash at 1Hz	Note Transport Error in Note Float
2 Flashes, pause (repeated)	Software Error
3 Flashes, pause (repeated)	Calibration Error
4 Flashes, pause (repeated)	Diverter Error
5 Flashes, pause (repeated)	Motor Timeout

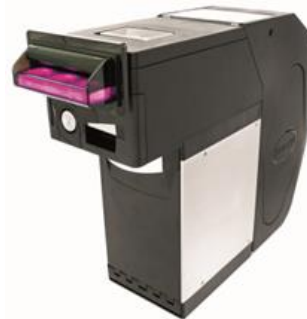
SMART Payout

Status Indicators		Flashes	Indicated Status / Error
Red	Green		
●		0	No Power
		1	Motor / Barcode Error
		2	Note Sensor Error
		3	EEPROM Error
		4	Payout Jammed
		5	Diverter Error
●	●	6	Detected a Note Movement
		0	
		1	Power Reset
		2	Wake Up from Low Power
		3	Software Reset
		4	Software Command
		5	User Manual Reset
	6	Power Supply Issue	
	7	Unknown Cause	
	●	1 Hz	All OK

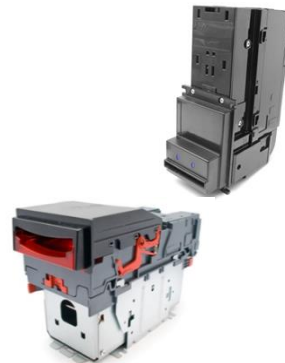
NV9 USB, NV10 USB, BV Series

No. of LONG flashes	No. of SHORT flashes				
	1	2	3	4	5
1	Note Path Open	Note Path Jam	Unit Not Initialized	Sensor Covered	
2	Cash Box Removed	Cash Box Jam			
3	Firmware Checksum	Interface Checksum	EEPROM Checksum	Dataset Checksum	Note Float Incompatible
4	PSU too Low	PSU too High
